Identifying Issues on Installed Photovoltaic Systems

Using this information for Trend Analysis

Fredrick Brooks, CEM, CEA

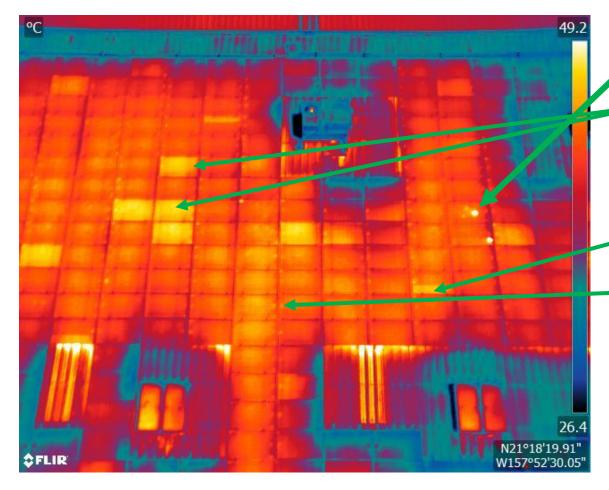
Hot Spot

Possible-Non-Working panel-(possible optimizer failure this particular optimizer) Possible Diode Issue Junction box and optimizer working on the panel- yes you can see that from this distance-

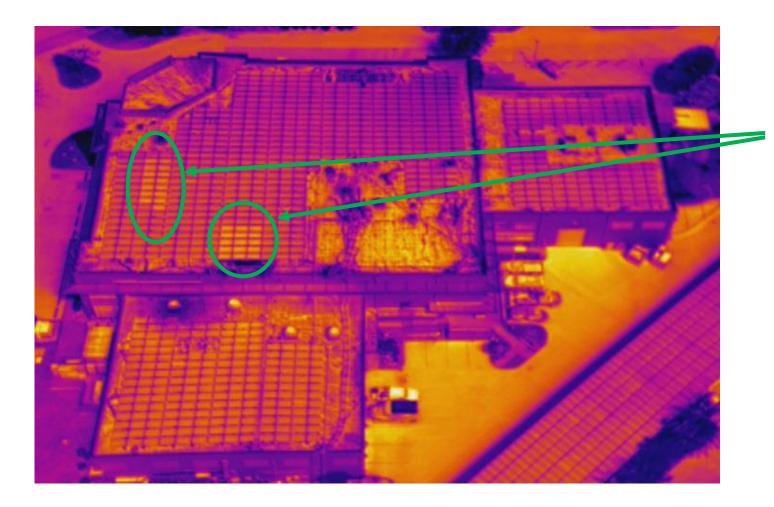
Non working string whole string is out

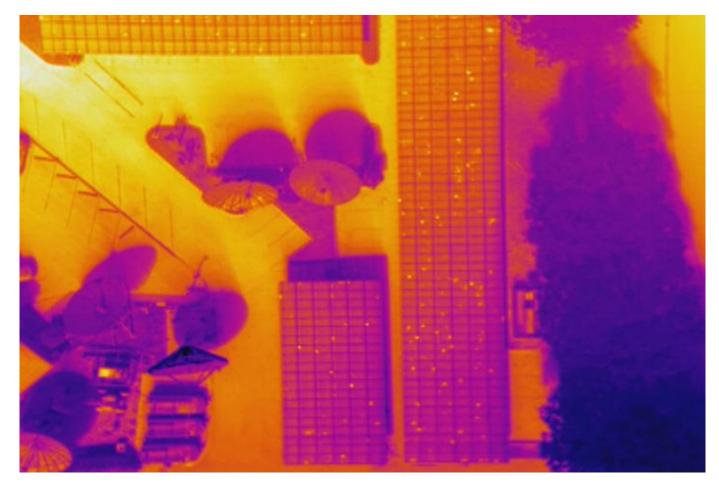
Too many anomalies to use an arrow here-You will state there are anomalies and can say hot spot possible diode, but you would need a closer look to verify them

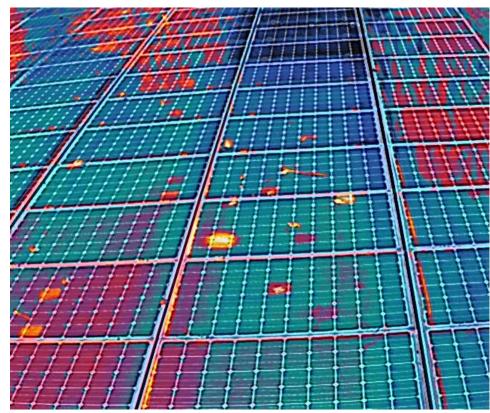
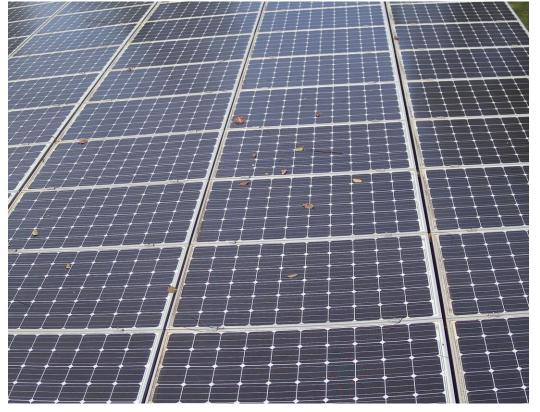
Thermal anomalies

Digital image showing leaves and twigs

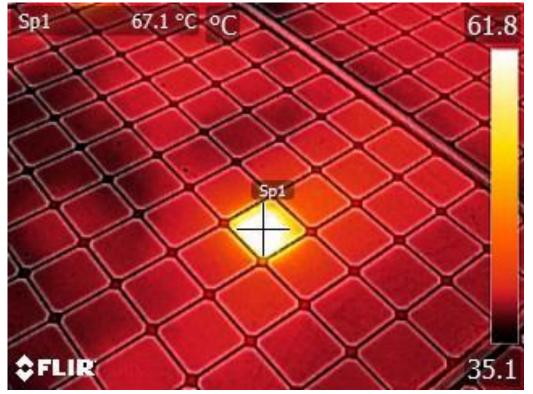
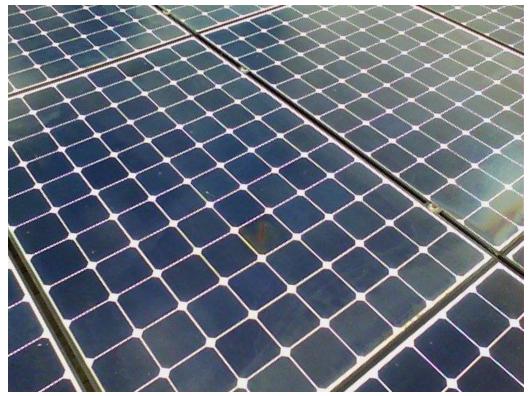
Thermal Hot Spot Found

Look to see if you see visible damage – this one actually had a visible marking

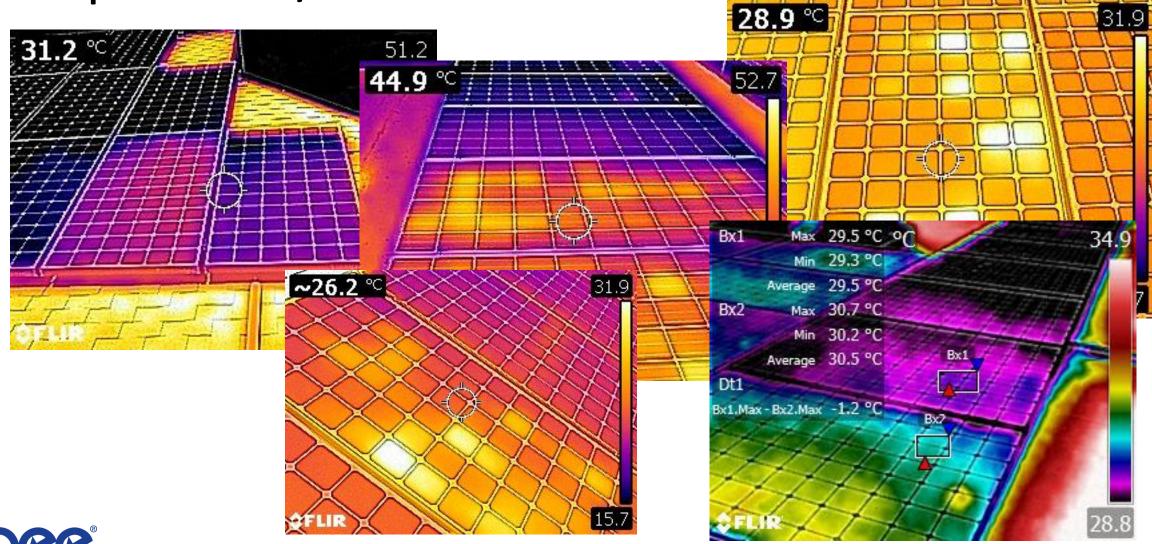
Optimizer / Micro Inverter Out

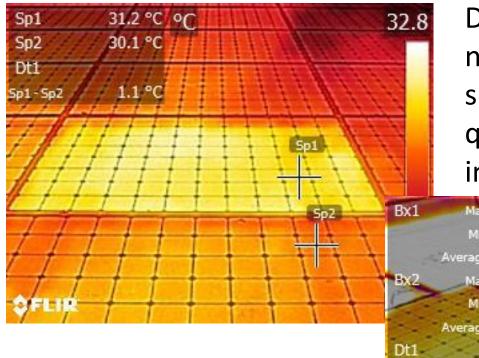
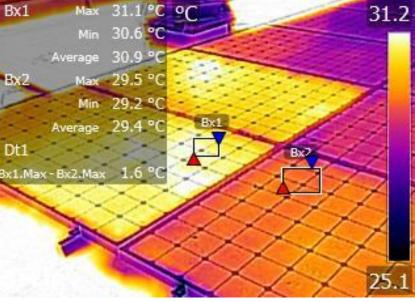
During a commissioning check we found panels not connected to there optimizers. It is a very small differential temperature to note and can be quite subtle, but it is identifiable, 1.1°C and 1.6°C in these images

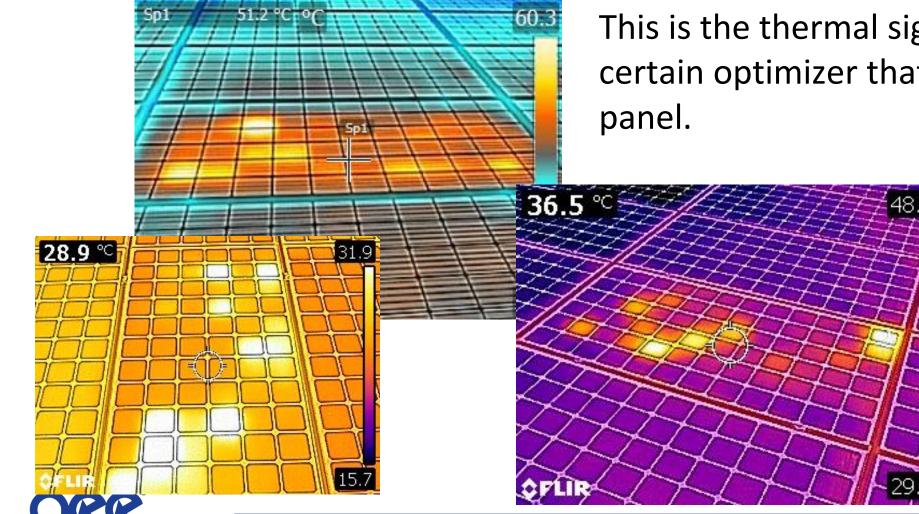
This is the thermal signature from a certain optimizer that has failed on a

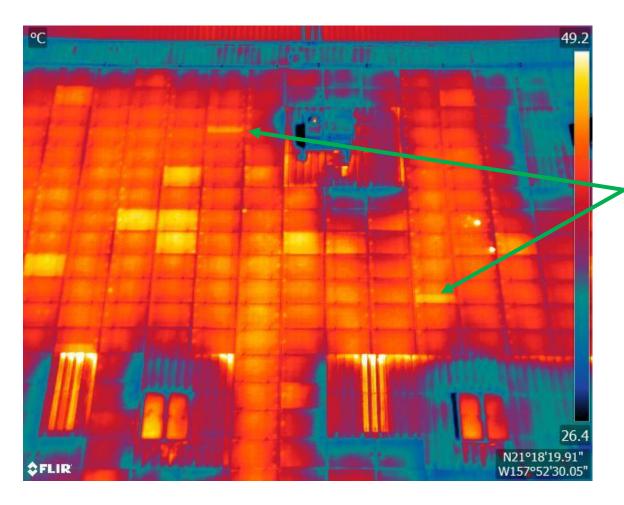
From the initial drone fly assessment I stated a possible diode issue on these two panels Identification of diode issues came from a job we did years ago and could not figure out the lower production in certain areas. Then the thermal camera identified the anomaly. The map matched and that was the answer – Failed Diodes-Those sites by the way are being completely changed out, as the trend kept showing more and more failures

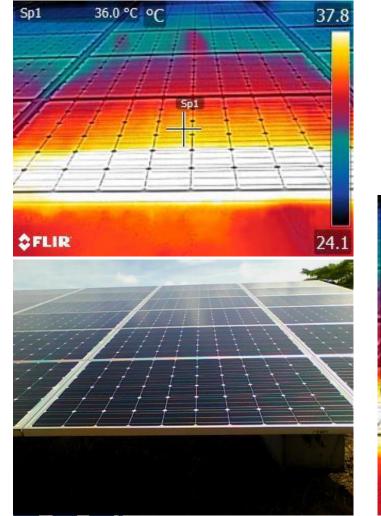
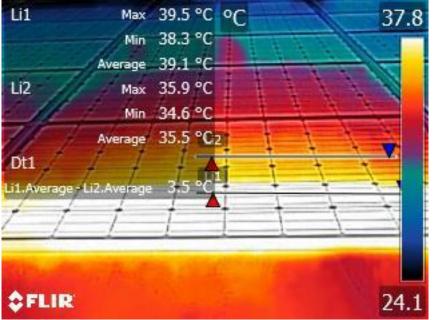
The diode failure on this shows one third of the panel with a heat signature difference. In this image we had a 3.5° C Δ t. These panels had 3 sets of diodes and you can see that one whole set has failed.

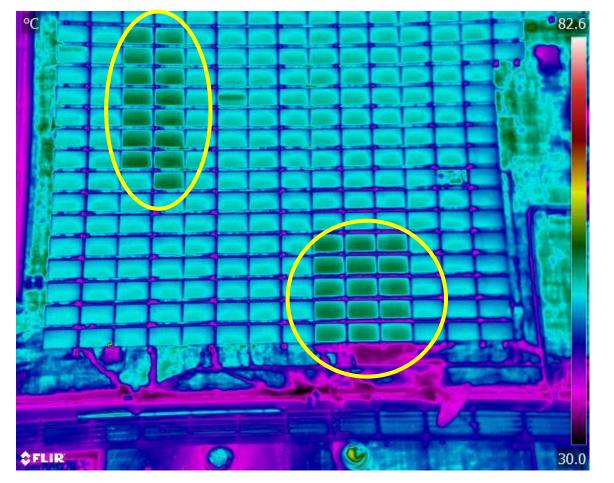
We can see the thermal anomaly difference on this image, we had the knowledge to know the system was in strings of 15 panels. This thermal anomaly came up and we can see the strings were down. Further testing did prove it, but this is pretty obvious. It helps you find a downed string quickly if you did not have a proper string map and happened to have tested first and found the downed string. This is a great way to find it.

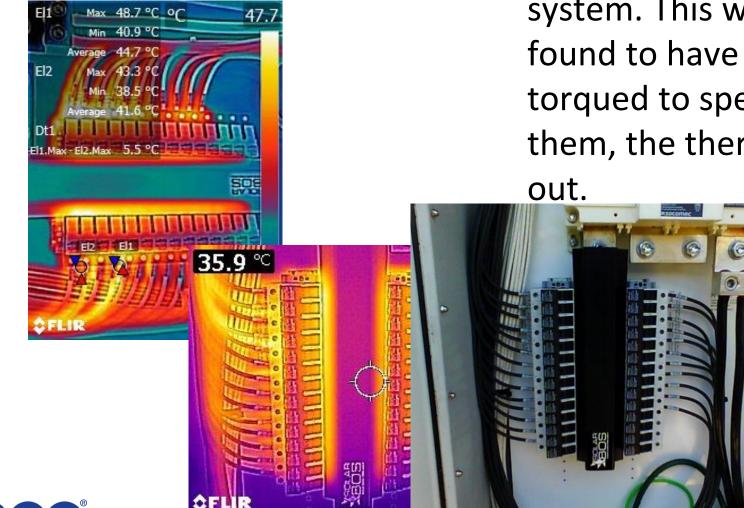
The thermal anomaly in this item is a **Combiner box items** hotter string during operations of the

system. This was then torque checked and found to have strings that were not torqued to specification. After we torqued them, the thermal signatures balanced

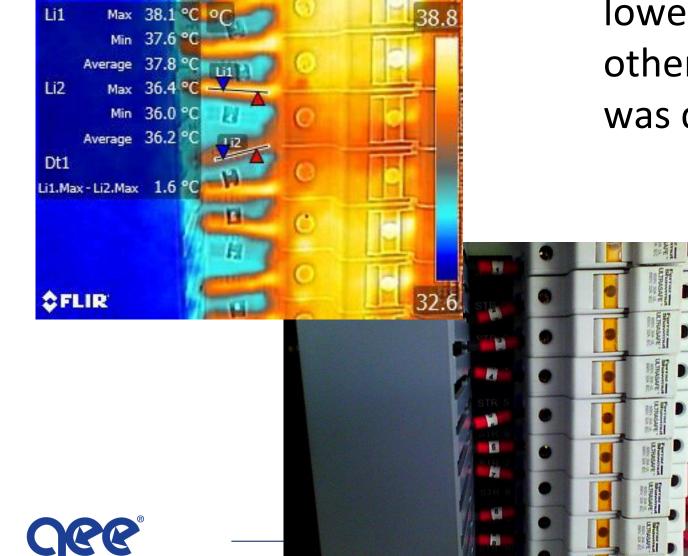
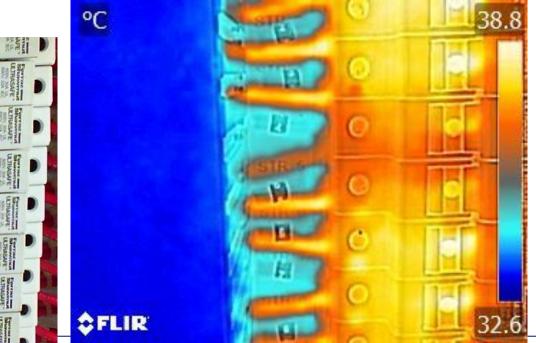
The thermal image you see on here shows a thermal anomaly that is a lower thermal signature than the others. This showed us the string was down. Had a Δt of 1.6°C

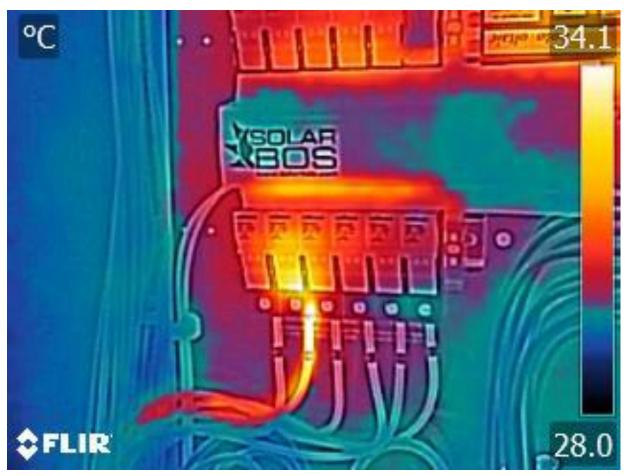
One of my favorite finds and helps us greatly on a optimizer system, this was a ground faulted string that faulted the inverter. The system was down not operating. Yet you can see this heat signature and it is showing you production, this strings was producing on itself. This saves on time in a major way to identify the string in question. This system had almost 50 strings to it. This was one of many combiner boxes.

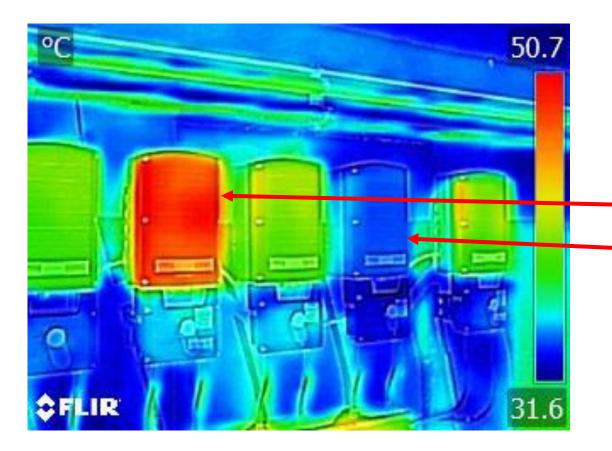
Inverters on a wall side by side quick glance with the thermal camera and we can say Fan not working Unit not running Others operating as expected

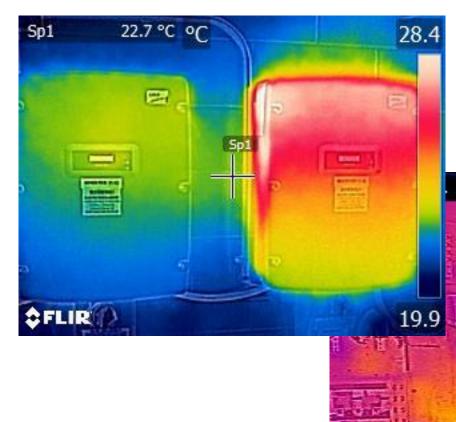
You are easily able to see which units may or may not be running and on a bigger unit you can see after you shut it off and open them, which blower may not be working. This one overheated and was burnt out
